Flood Control Project Maintenance
2014 Structure Summary Report
Overall Unit and Item Ratings

Lower San Joaquin Levee District

Ash Slough Drop Structure No. 1

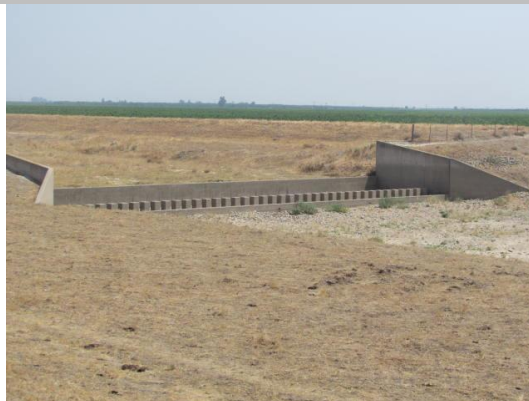
Photo 1 of 3 : ST_2014_NA0010_24_1_20140811_00007.jpg

Looking east at overview of structure.

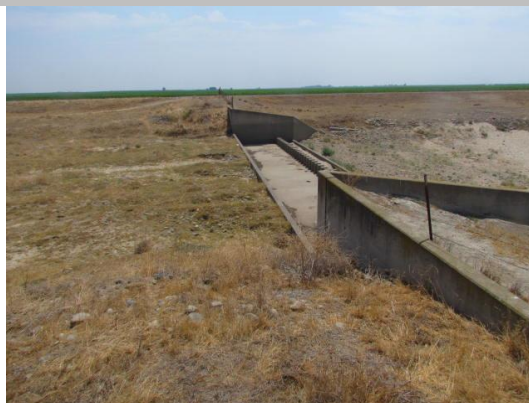
Photo 2 of 3 : ST_2014_NA0010_24_1_20140811_00008.jpg

Looking south at upstream side of structure.

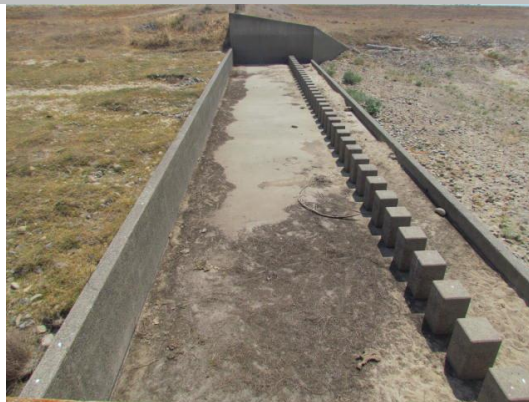
Photo 3 of 3 : ST_2014_NA0010_24_1_20140811_00009.jpg

Looking south at base of structure.

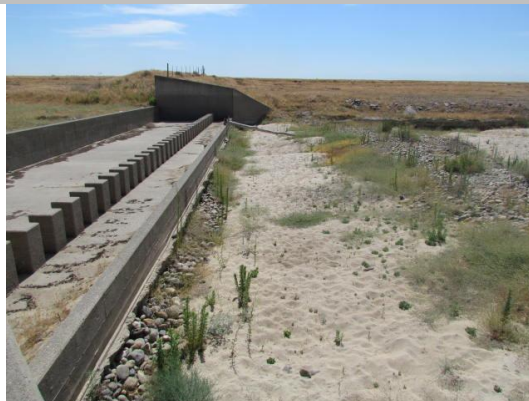
Photo 1 of 1 : ST_2014_NA0010_24_5_20140710_00004.jpg

LM Start	0.00	Rating **	M	Issue No.	5
LM End	0.00	Issue Type +	Ma	Location *	
Category	Structures & Concrete Lined Channels			GPS Latitude/Longitude	
				Start	End
Item	Revetments			37.033952 °	37.033952 °
				-120.441733 °	-120.441733 °
DWR ID	DWR_NA0010_24_t_2012_5				
Action/Comments					
Inspector Comments: Riprap displacement on the downstream and upstream side should be maintained.

Looking at downstream side of structure.

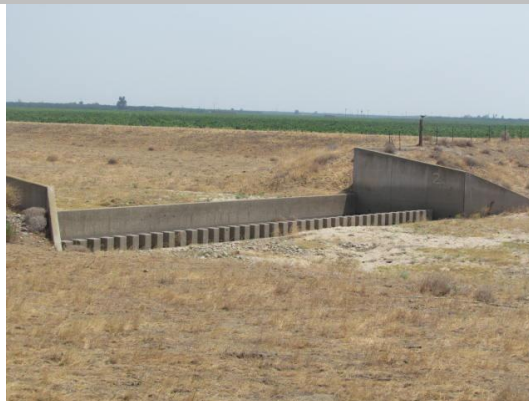
Photo 1 of 1 : ST_2014_NA0010_25_1_20140811_00010.jpg

Looking east at downstream side of structure.

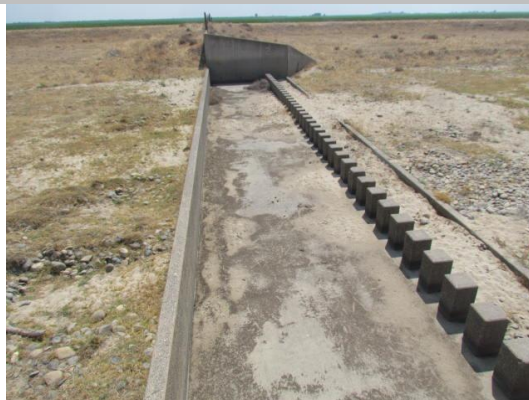
Photo 1 of 1 : ST_2014_NA0010_25_5_20140811_00011.jpg

LM Start	0.00	Rating **	M	Issue No.	5
LM End	0.00	Issue Type +	Ma	Location *	
Category	Structures & Concrete Lined Channels			GPS Latitude/Longitude	
				Start	End
Item	Revetments			37.037853 °	37.037853 °
				-120.440067 °	-120.440067 °
DWR ID	DWR_NA0010_25_t_2012_5				
Action/Comments					
Inspector Comments: Riprap should be properly maintained.

Looking north at revetments on downstream side of structure.

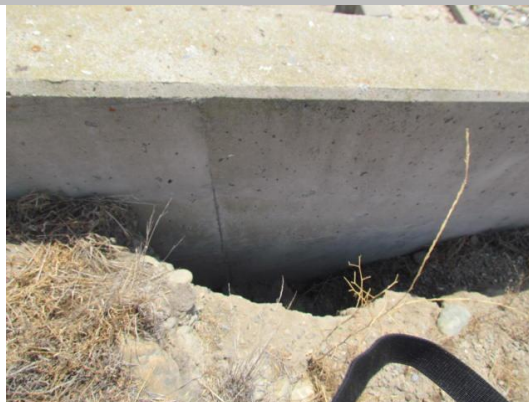
Photo 2 of 2 : ST_2014_NA0010_25_17_20140811_00013.jpg

LM Start	0.00	Rating **	M	Issue No.	17
LM End	0.00	Issue Type +	Ma	Location *	
Category	Structures & Concrete Lined Channels			GPS Latitude/Longitude	
				Start	End
Item	Concrete Foundations			37.037853 °	37.037853 °
				-120.440067 °	-120.440067 °
DWR ID	DWR_NA0010_25_t_2012_17				
Action/Comments					
Inspector Comments: Large hole on the right wing wall 2-3 feet wide and 4-5 feet deep and 12-14 feet long.

Looking north at hole near right wing wall.

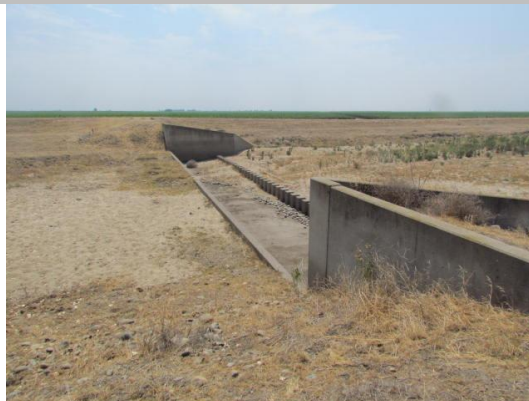
Photo 1 of 2 : ST_2014_NA0010_26_1_20140811_00001.jpg

Looking north at upstream side of structure.

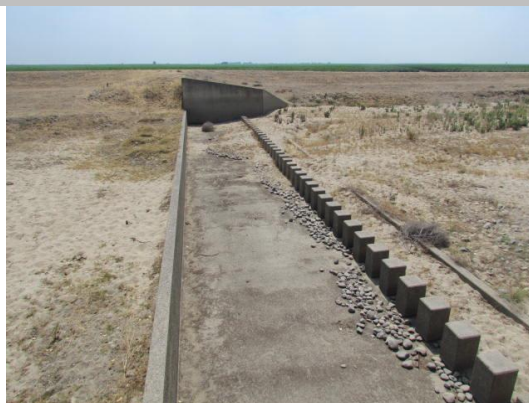
Photo 2 of 2 : ST_2014_NA0010_26_1_20140811_00002.jpg

Looking north at overview of structure.

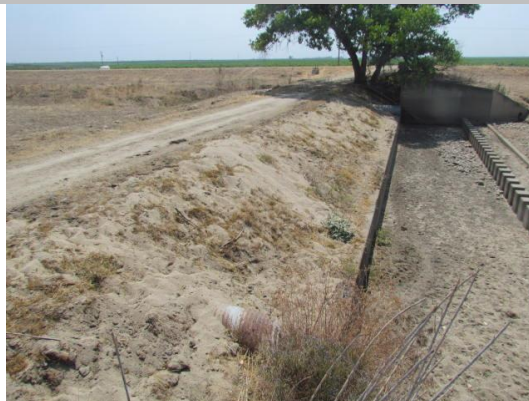
Photo 1 of 1 : ST_2014_NA0010_27_1_20140811_00007.jpg

Looking north at overview of structure.

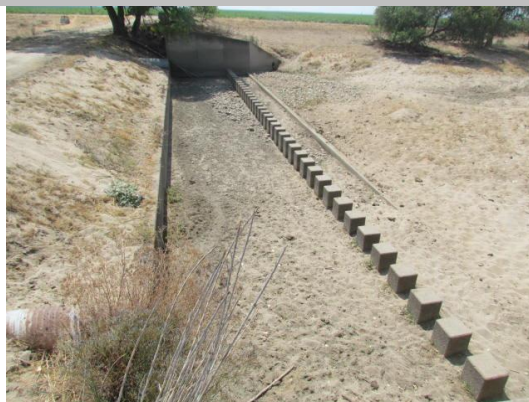
Photo 1 of 1 : ST_2014_NA0010_27_5_20140811_00008.jpg

LM Start	0.00	Rating **	M	Issue No.	5
LM End	0.00	Issue Type +	Ma	Location *	
Category	Structures & Concrete Lined Channels	GPS Latitude/Longitude			
		Start		End	
Item	Revetments	37.045045 °		37.045045 °	
		-120.429855 °		-120.429855 °	
DWR ID	DWR_NA0010_27_t_2012_5				
Action/Comments					
Inspector Comments: No riprap on the upstream side of structure.

Looking at downstream side of structure.

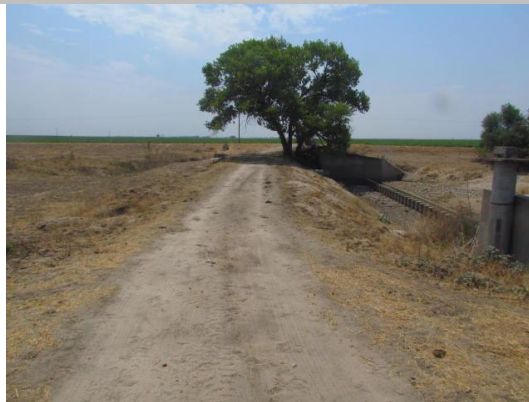
Photo 1 of 2 : ST_2014_NA0010_27_6_20140811_00009.jpg

LM Start	0.00	Rating **	M	Issue No.	6	
LM End	0.00	Issue Type +	En	Location *		
Category	Structures & Concrete Lined Channels			GPS Latitude/Longitude		
				Start		End
Item	Encroachments			37.045045 °		37.045045 °
				-120.429855 °		-120.429855 °
DWR ID	DWR_NA0010_27_t_2012_6					
Action/Comments						
Inspector Comments: Landowner blocking structure with sand dam. The dam would likely wash out during a high water event.

Looking north at overview of sand dam on upstream side of structure.

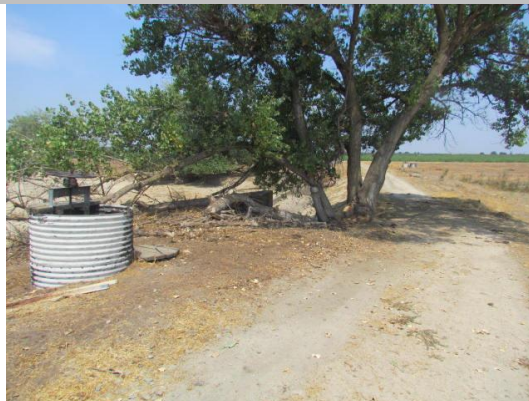
Photo 2 of 2 : ST_2014_NA0010_27_6_20140811_00010.jpg

LM Start	0.00	Rating **	M	Issue No.	6 (cont)	
LM End	0.00	Issue Type +	En	Location *		
Category	Structures & Concrete Lined Channels			GPS Latitude/Longitude		
				Start		End
Item	Encroachments			37.045045 °	37.045045 °	
				-120.429855 °	-120.429855 °	
DWR ID	DWR_NA0010_27_t_2012_6					
Action/Comments						
Inspector Comments: Landowner blocking structure with sand dam. The dam would likely wash out during a high water event.

Looking south at down tree limbs on downstream of structure.

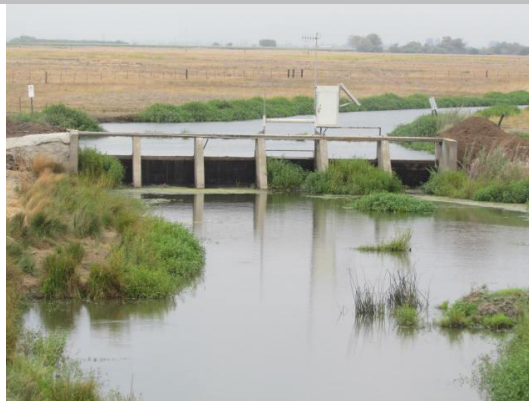
Photo 1 of 2 : ST_2014_NA0010_34_1_20140812_00014.jpg

LM Start	0.00	Rating **	N	Issue No.	1	
LM End	0.00	Issue Type +	Ma	Location *		
Category	Structures & Concrete Lined Channels			GPS Latitude/Longitude		
				Start	End	
Item	Photo Documentation			37.254970 °	37.254970 °	
				-120.718450 °	-120.718450 °	
DWR ID	DWR_NA0010_34_t_2012_1					
Action/Comments						
Inspector Comments: Item appears to be acceptably maintained.

Looking east at downstream side of structure.

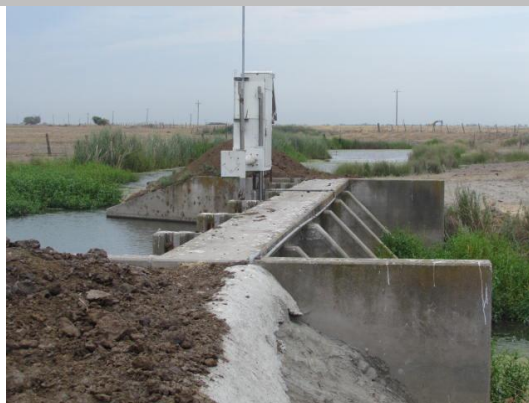
Photo 2 of 2 : ST_2014_NA0010_34_1_20140812_00015.jpg

Looking north at overview of structure.

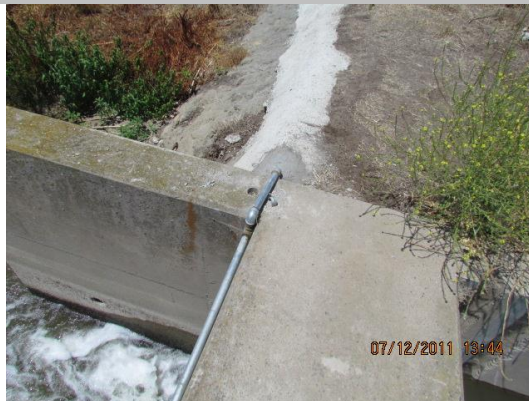
Photo 1 of 3 : ST_2014_NA0010_34_6_20140710_00003.jpg

LM Start	0.00	Rating **	A	Issue No.	6
LM End	0.00	Issue Type +	Ma	Location *	
Category	Structures & Concrete Lined Channels			GPS Latitude/Longitude	
				Start	End
Item	Encroachments			37.254970 °	37.254970 °
				-120.718450 °	-120.718450 °
DWR ID	DWR_NA0010_34_t_2012_6				
Action/Comments					
Inspector Comments: Steveson Irrigation replaced pvc electrical conduit with half inch steel pipe.

Looking at new electrical conduit on downstream side of structure.

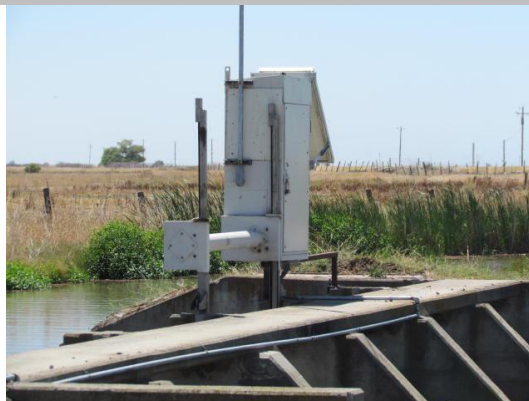
Photo 2 of 3 : ST_2014_NA0010_34_6_20140710_00004.jpg

Looking north at electric control gate on east side of structure.

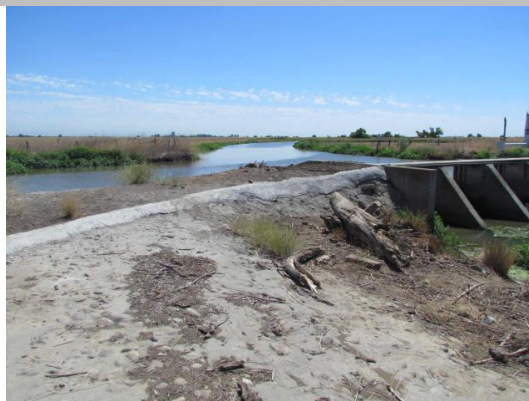
Photo 3 of 3 : ST_2014_NA0010_34_6_20140710_00005.jpg

Looking east at electrical conduit trench on southside of structure.

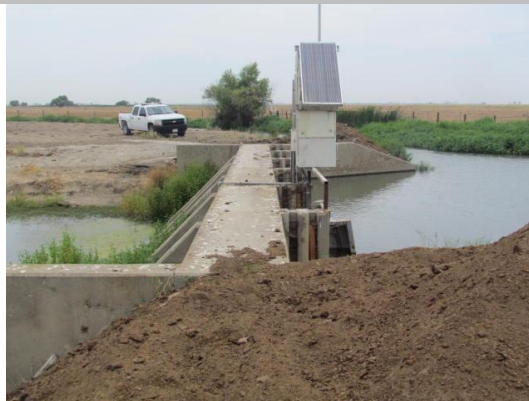
Photo 1 of 1 : ST_2014_NA0010_34_13_20140812_00017.jpg

LM Start	0.00	Rating **	A	Issue No.	13
LM End	0.00	Issue Type +	Ma	Location *	
Category	Structures & Concrete Lined Channels			GPS Latitude/Longitude	
				Start	End
Item	Electric Gate Operators			37.254970 °	37.254970 °
				-120.718450 °	-120.718450 °
DWR ID	DWR_NA0010_34_t_2012_13				
Action/Comments					
Inspector Comments: Steven Irrigation District installed an electric gate on upstream side of structure. CVFPB approved permit for electric gate.

Looking south at electric gate operators on upstream side of structure.

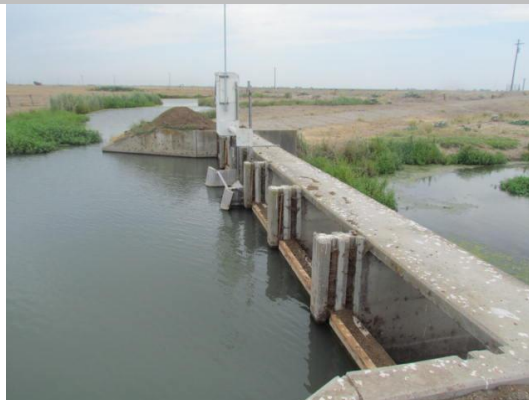
Photo 1 of 2 : ST_2014_NA0010_34_17_20140812_00018.jpg

LM Start	0.00	Rating **	A	Issue No.	17
LM End	0.00	Issue Type +	Ma	Location *	
Category	Structures & Concrete Lined Channels			GPS Latitude/Longitude	
				Start	End
Item	Concrete Foundations			37.254970 °	37.254970 °
				-120.718450 °	-120.718450 °
DWR ID	DWR_NA0010_34_t_2012_17				
Action/Comments					
Inspector Comments: No visible erosion near foundation.

Looking north at upstream side of structure.

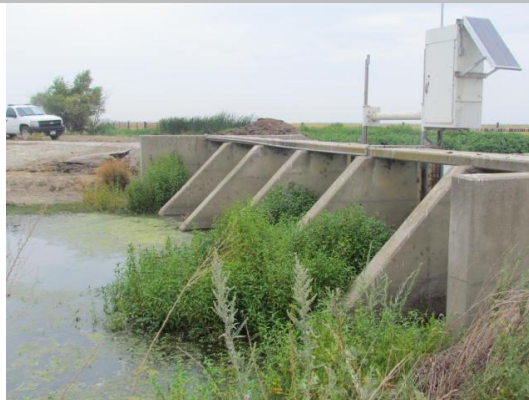
Photo 2 of 2 : ST_2014_NA0010_34_17_20140812_00019.jpg

Looking south at downstream side of structure.

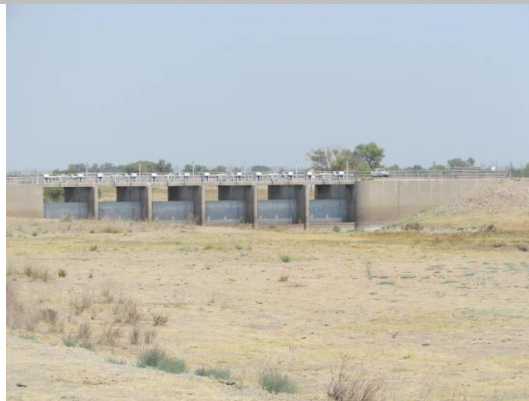
Photo 1 of 3 : ST_2014_NA0010_43_1_20140812_00008.jpg

Looking east at upstream side of structure.

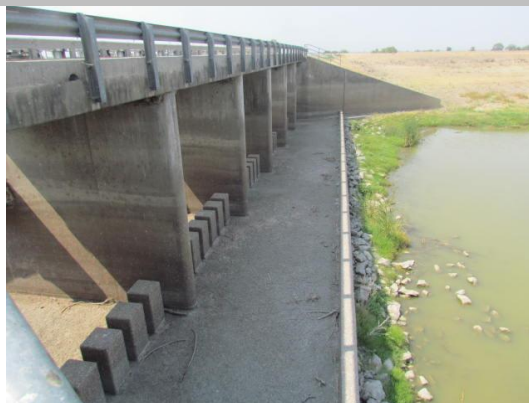
Photo 2 of 3 : ST_2014_NA0010_43_1_20140812_00014.jpg

Looking at south at downstream side of structure.

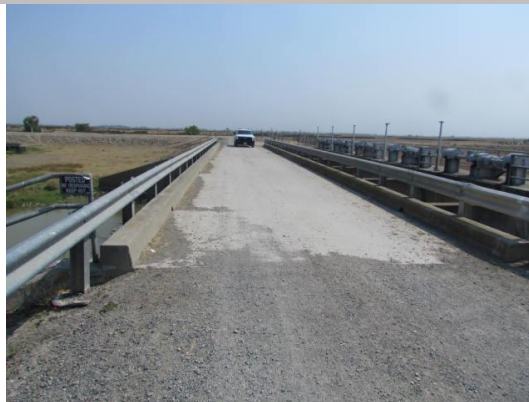
Photo 3 of 3 : ST_2014_NA0010_43_1_20140812_00009.jpg

Looking north at top of structure.

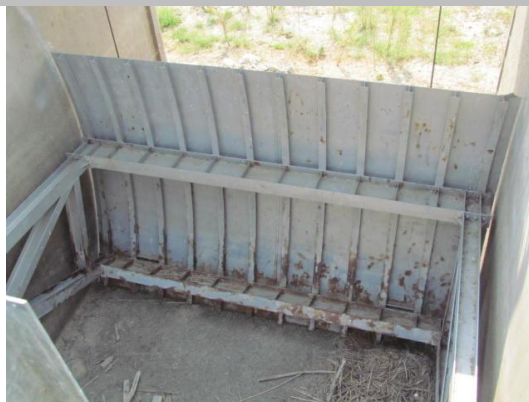
Photo 1 of 2 : ST_2014_NA0010_43_12_20140812_00010.jpg

LM Start	0.00	Rating **	A	Issue No.	12
LM End	0.00	Issue Type +	Ma	Location *	
Category	Structures & Concrete Lined Channels	GPS Latitude/Longitude			
		Start	End		
Item	Sluice/Slide Gates	37.204867 °		37.204867 °	
		-120.696985 °		-120.696985 °	
DWR ID	DWR_NA0010_43_t_2012_12				
Action/Comments					
Inspector Comments: Item appears to be adequately maintained and able to perform as intended. But grease fittings are not connect to hinge point on gates.

Looking at typical view of control gates.

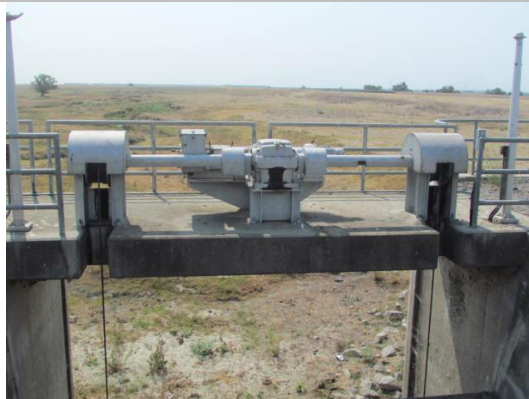
Photo 1 of 3 : ST_2014_NA0010_43_13_20140812_00011.jpg

LM Start	0.00	Rating **	A	Issue No.	13
LM End	0.00	Issue Type +	Ma	Location *	
Category	Structures & Concrete Lined Channels			GPS Latitude/Longitude	
				Start	End
Item	Electric Gate Operators			37.204867 °	37.204867 °
				-120.696985 °	-120.696985 °
DWR ID	DWR_NA0010_43_t_2012_13				
Action/Comments					
Inspector Comments: Item appears to be adequately maintained and

Looking west at electric motor on upstream side of structure.

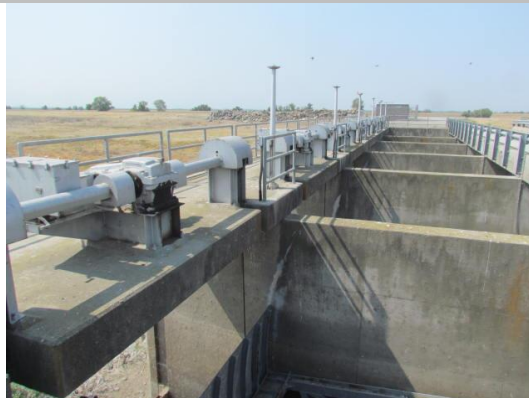
Photo 2 of 3 : ST_2014_NA0010_43_13_20140812_00015.jpg

Looking south at electric motors on upstream side of structure.

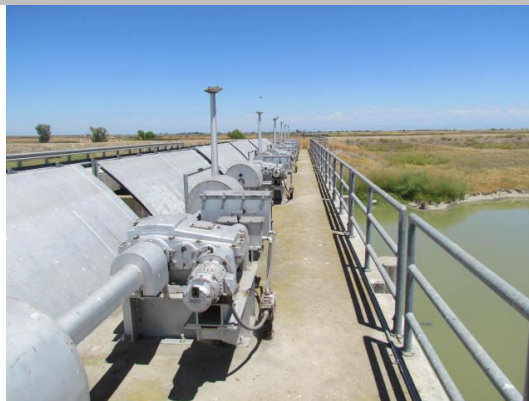
Photo 3 of 3 : ST_2014_NA0010_43_13_20140710_00005.jpg

Looking north at several electric motors on upstream side of structure.

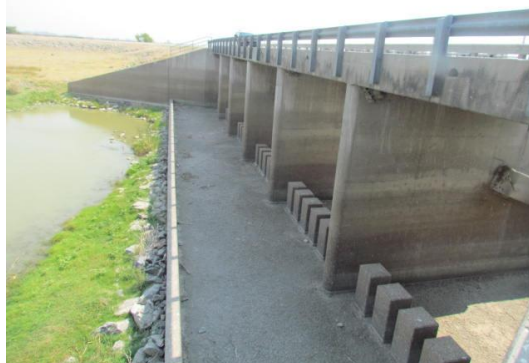
Photo 1 of 2 : ST_2014_NA0010_43_17_20140812_00012.jpg

LM Start	0.00	Rating **	A	Issue No.	17
LM End	0.00	Issue Type +	Ma	Location *	
Category	Structures & Concrete Lined Channels			GPS Latitude/Longitude	
				Start	End
Item	Concrete Foundations			37.204867 °	37.204867 °
				-120.696985 °	-120.696985 °
DWR ID	DWR_NA0010_43_t_2012_17				
Action/Comments					
Inspector Comments: No visible erosion near foundation.

Looking north at downstream side of structure.

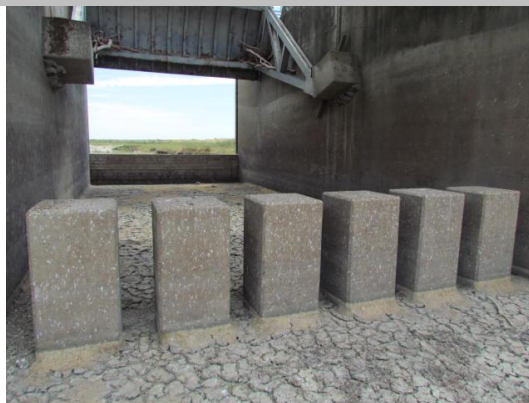
Photo 2 of 2 : ST_2014_NA0010_43_17_20140710_00006.jpg

Looking at typical of control structure bay.

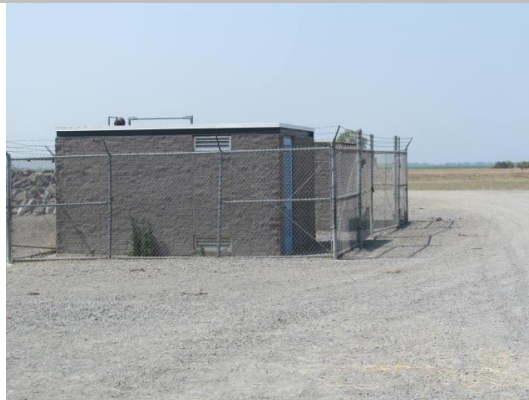
Photo 2 of 2 : ST_2014_NA0010_43_23_20140812_00013.jpg

LM Start	0.00	Rating **	M	Issue No.	23
LM End	0.00	Issue Type +	Ma	Location *	
Category	Structures & Concrete Lined Channels			GPS Latitude/Longitude	
				Start	End
Item	Safety			37.204867 °	37.204867 °
				-120.696985 °	-120.696985 °
DWR ID	DWR_NA0010_43_t_2012_23				
Action/Comments					
Inspector Comments: Need to replace light fixtures on upstream side of structure.

Looking south control building and fencing.

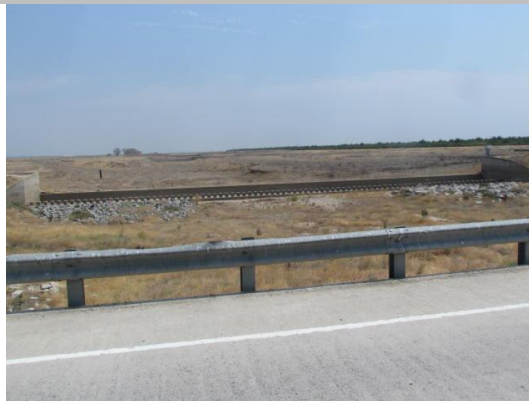
Photo 1 of 3 : ST_2014_NA0010_29_1_20140812_00006.jpg

Looking south at an overview of structure on downstream side.

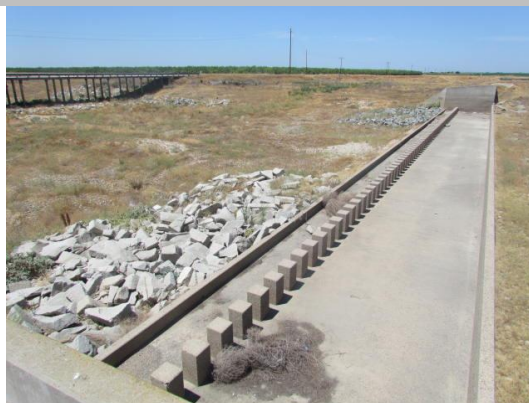
Photo 2 of 3 : ST_2014_NA0010_29_1_20140710_00002.jpg

Looking southwest at downstream side of structure.

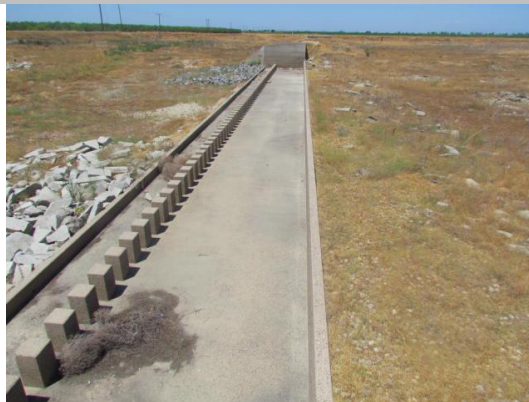
Photo 3 of 3 : ST_2014_NA0010_29_1_20140710_00003.jpg

Looking at an overview of structure.

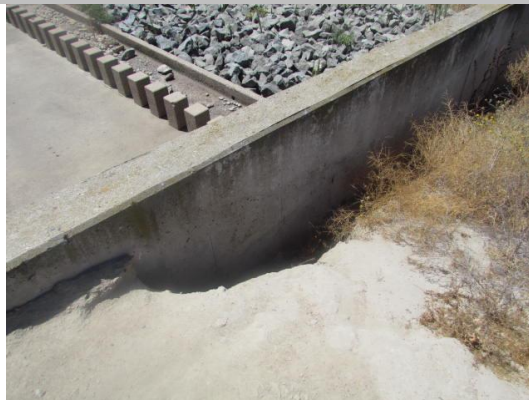
Photo 1 of 1 : ST_2014_NA0010_29_4_20140710_00004.jpg

LM Start	0.00	Rating **	M	Issue No.	4
LM End	0.00	Issue Type +	Ma	Location *	
Category	Structures & Concrete Lined Channels			GPS Latitude/Longitude	
				Start	End
Item	Erosion / Bank Caving			36.976928 °	36.976928 °
				-120.382103 °	-120.382103 °
DWR ID	DWR_NA0010_29_t_2012_4				
Action/Comments					
Inspector Comments: Some minor caving on right wing wall.

Looking at erosion/caving on right wing wall.

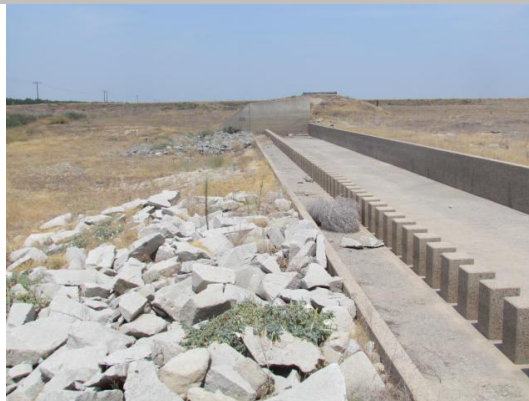
Photo 1 of 1 : ST_2014_NA0010_29_5_20140812_00007.jpg

LM Start	0.00	Rating **	A	Issue No.	5	
LM End	0.00	Issue Type +	Ma	Location *		
Category	Structures & Concrete Lined Channels			GPS Latitude/Longitude		
				Start	End	
Item	Revetments			36.976928 °	36.976928 °	
				-120.382103 °	-120.382103 °	
DWR ID	DWR_NA0010_29_t_2012_5					
Action/Comments						
Inspector Comments: Item appears to be acceptably maintained

Looking south at revetment on downstream side of structure.

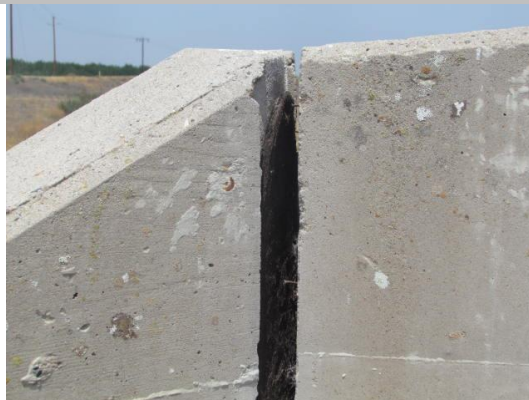
Photo 1 of 1 : ST_2014_NA0010_29_22_20140812_00008.jpg

LM Start	0.00	Rating **	A	Issue No.	22
LM End	0.00	Issue Type +	Ma	Location *	
Category	Structures & Concrete Lined Channels			GPS Latitude/Longitude	
				Start	End
Item	Monolith Joints			36.976928 °	36.976928 °
				-120.382103 °	-120.382103 °
DWR ID	DWR_NA0010_29_t_2012_22				
Action/Comments					
Inspector Comments: Some minor movement at wing wall joint.

Looking at right wing wall.

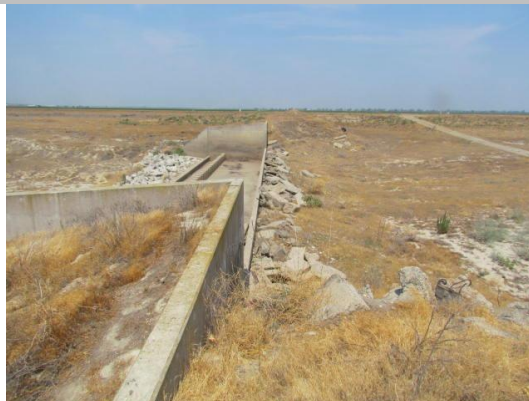
Photo 1 of 2 : ST_2014_NA0010_30_1_20140812_00006.jpg

Looking south at upstream side of structure.

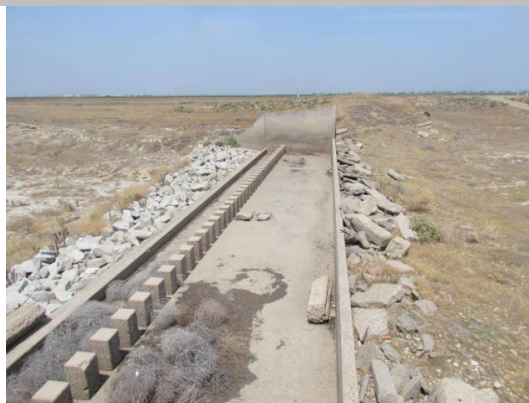
Photo 2 of 2 : ST_2014_NA0010_30_1_20140812_00008.jpg

Looking south at an overview of structure.

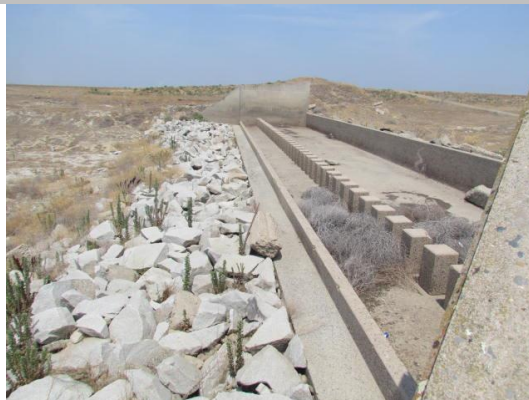
Photo 1 of 1 : ST_2014_NA0010_30_5_20140812_00007.jpg

LM Start	0.00	Rating **	A	Issue No.	5
LM End	0.00	Issue Type +	Ma	Location *	
Category	Structures & Concrete Lined Channels			GPS Latitude/Longitude	
				Start	End
Item	Revetments			36.975357 °	36.975357 °
				-120.374833 °	-120.374833 °
DWR ID	DWR_NA0010_30_t_2012_5				
Action/Comments					
Inspector Comments: Revetment appears to be properly maintained.

Looking south at revetment on downstream side of structure.

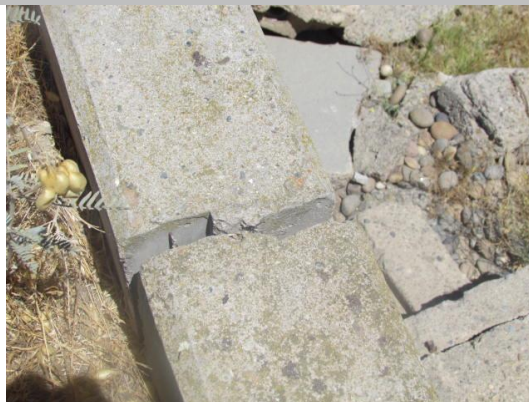
Photo 2 of 2 : ST_2014_NA0010_30_22_20140710_00005.jpg

LM Start	0.00	Rating **	M	Issue No.	22
LM End	0.00	Issue Type +	Ma	Location *	
Category	Structures & Concrete Lined Channels			GPS Latitude/Longitude	
				Start	End
Item	Monolith Joints			36.975357 °	36.975357 °
				-120.374833 °	-120.374833 °
DWR ID	DWR_NA0010_30_t_2012_22				
Action/Comments					
Inspector Comments: Rubber seal deteriorated between joints.

Looking at joint separation on left side of structure.

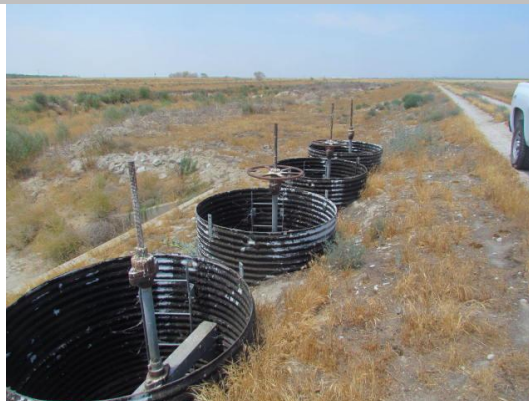
Photo 1 of 2 : ST_2014_NA0010_39_1_20140812_00010.jpg

Looking west at screw gates on downstream side of structure.

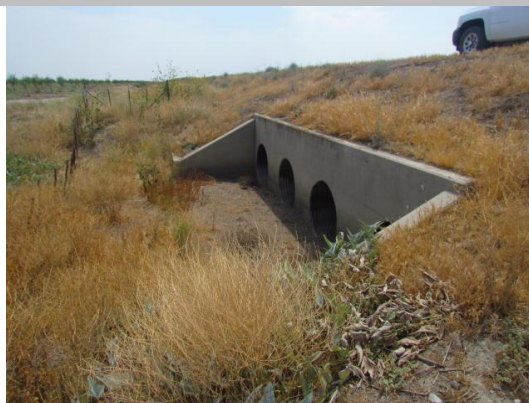
Photo 2 of 2 : ST_2014_NA0010_39_1_20140812_00011.jpg

Looking southwest at upstream side of structure.

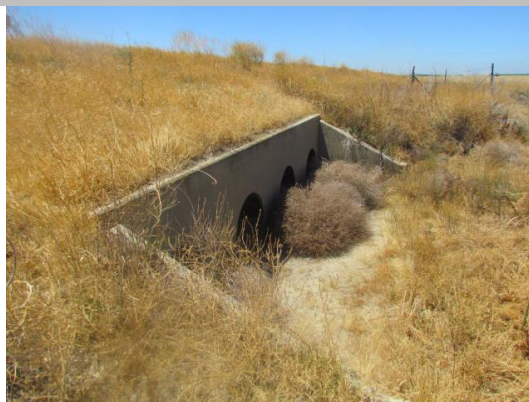
Photo 1 of 1 : ST_2014_NA0010_39_7_20140710_00004.jpg

LM Start	0.00	Rating **	A	Issue No.	7
LM End	0.00	Issue Type +	Ma	Location *	
Category	Structures & Concrete Lined Channels			GPS Latitude/Longitude	
				Start	End
Item	Culverts: Inlets / Outlets			36.975418 °	36.975418 °
				-120.359578 °	-120.359578 °
DWR ID	DWR_NA0010_39_t_2012_7				
Action/Comments					
Inspector Comments: No visible debris blocking item.

Looking west at overview of inlet.

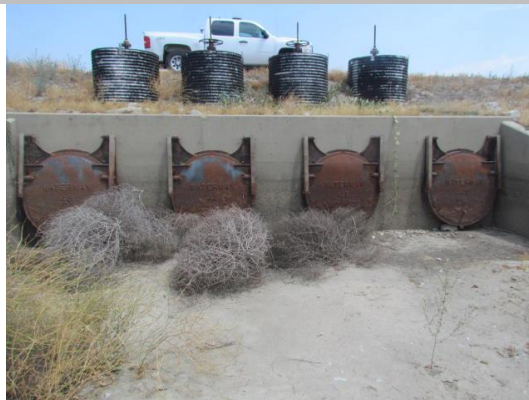
Photo 1 of 1 : ST_2014_NA0010_39_11_20140812_00012.jpg

LM Start	0.00	Rating **	A	Issue No.	11
LM End	0.00	Issue Type +	Ma	Location *	
Category	Structures & Concrete Lined Channels	GPS Latitude/Longitude			
		Start		End	
Item	Flap Gates	36.975418 °		36.975418 °	
		-120.359578 °		-120.359578 °	
DWR ID	DWR_NA0010_39_t_2012_11				
Action/Comments					
Inspector Comments: Flap gates appear and good condition.

Looking east at flap gates on downstream side of structure.

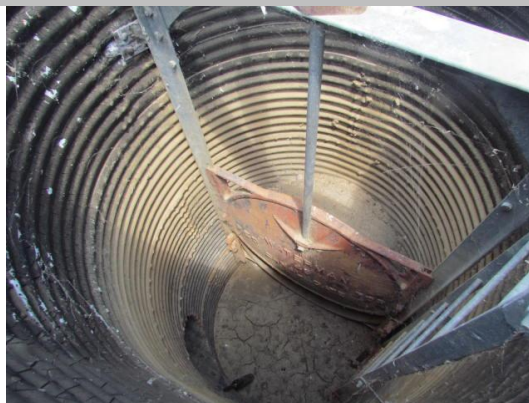
Photo 1 of 1 : ST_2014_NA0010_39_12_20140812_00013.jpg

LM Start	0.00	Rating **	A	Issue No.	12
LM End	0.00	Issue Type +	Ma	Location *	
Category	Structures & Concrete Lined Channels			GPS Latitude/Longitude	
				Start	End
Item	Sluice/Slide Gates			36.975418 °	36.975418 °
				-120.359578 °	-120.359578 °
DWR ID	DWR_NA0010_39_t_2012_12				
Action/Comments					
Inspector Comments: Slide gates appear in good condition.

Looking at typical view of slide gate located inside can.

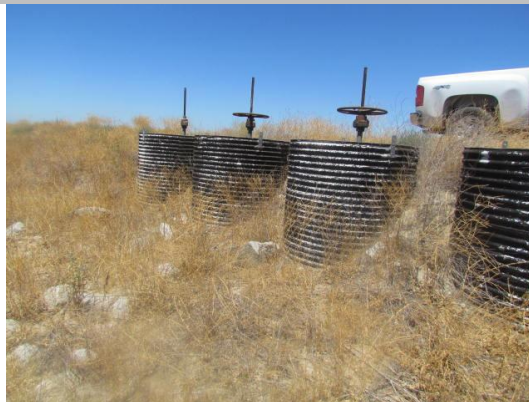
Photo 1 of 1 : ST_2014_NA0010_39_14_20140710_00007.jpg

LM Start	0.00	Rating **	A	Issue No.	14
LM End	0.00	Issue Type +	Ma	Location *	
Category	Structures & Concrete Lined Channels			GPS Latitude/Longitude	
				Start	End
Item	Manual Gate Operators			36.975418 °	36.975418 °
				-120.359578 °	-120.359578 °
DWR ID	DWR_NA0010_39_t_2012_14				
Action/Comments					
Inspector Comments: Missing wheel on screw gate.

Looking south at screw gates

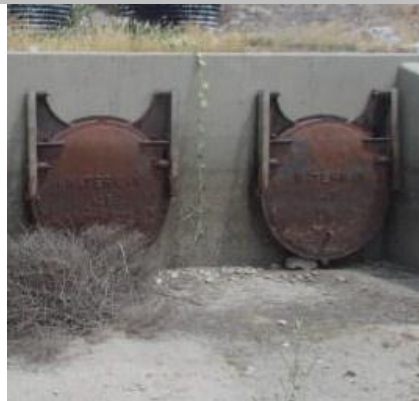
Photo 1 of 1 : ST_2014_NA0010_39_21_20140812_00014.jpg

LM Start	0.00	Rating **	M	Issue No.	21
LM End	0.00	Issue Type +	Ma	Location *	
Category	Structures & Concrete Lined Channels			GPS Latitude/Longitude	
				Start	End
Item	Other Metallic Items			36.975418 °	36.975418 °
				-120.359578 °	-120.359578 °
DWR ID	DWR_NA0010_39_t_2012_21				
Action/Comments					
Inspector Comments: Minor corrosion seen on flap gates.

Looking at flap gates on downstream side of structure.

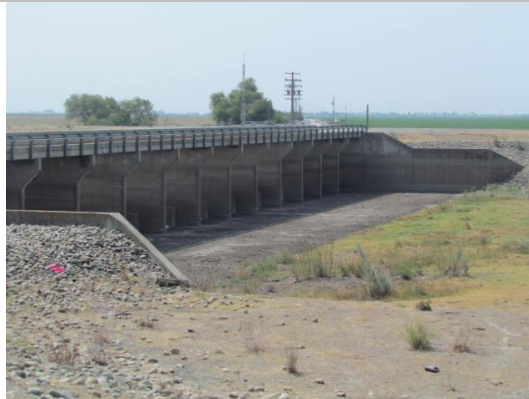
Photo 1 of 3 : ST_2014_NA0010_44_1_20140812_00011.jpg

Looking south at downstream side of structure.

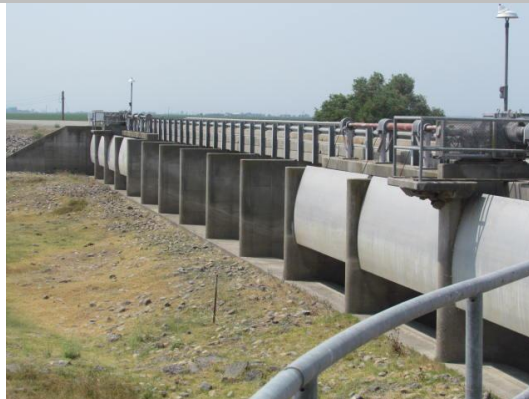
Photo 2 of 3 : ST_2014_NA0010_44_1_20140812_00012.jpg

Looking south at upstream side of structure.

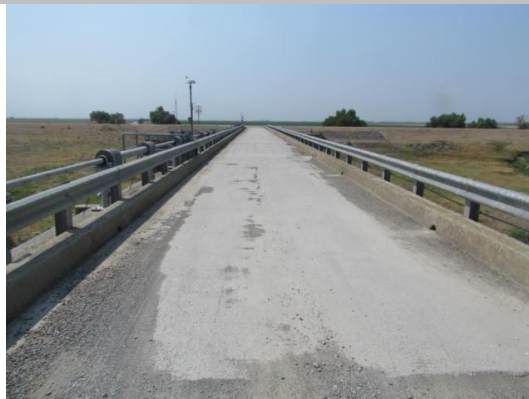
Photo 3 of 3 : ST_2014_NA0010_44_1_20140812_00013.jpg

Looking south at top of structure.

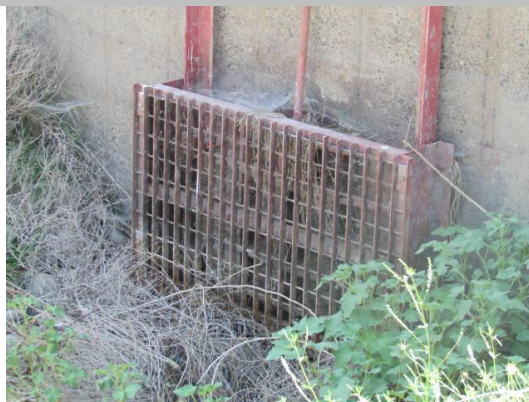
Photo 1 of 1 : ST_2014_NA0010_44_10_20140710_00006.jpg

LM Start	0.00	Rating **	A	Issue No.	10
LM End	0.00	Issue Type +	Ma	Location *	WS
Category	Structures & Concrete Lined Channels			GPS Latitude/Longitude	
				Start	End
Item	Trash Racks			37.201538 °	37.201538 °
				-120.694813 °	-120.694813 °
DWR ID	DWR_NA0010_44_t_2012_10				
Action/Comments					
Inspector Comments: Track rack on manual control gate in good condition.

Looking southwest at trash rack on downstream side of structure.

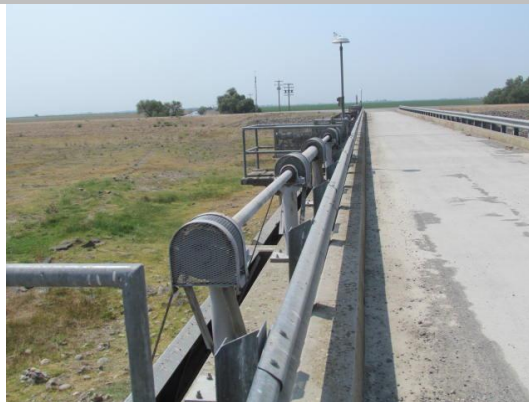
Photo 1 of 2 : ST_2014_NA0010_44_13_20140812_00014.jpg

LM Start	0.00	Rating **	A	Issue No.	13
LM End	0.00	Issue Type +	Ma	Location *	WS
Category	Structures & Concrete Lined Channels			GPS Latitude/Longitude	
				Start	End
Item	Electric Gate Operators			37.201538 °	37.201538 °
				-120.694813 °	-120.694813 °
DWR ID	DWR_NA0010_44_t_2012_13				
Action/Comments					
Inspector Comments: Electrical gates appear to be in proper working condition.

Looking south at typical view of electric gates on downstream side of structure.

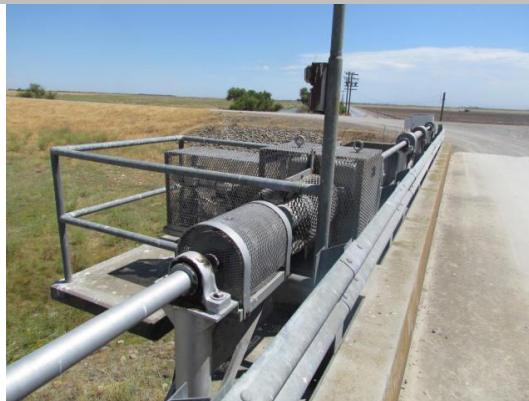
Photo 2 of 2 : ST_2014_NA0010_44_13_20140710_00008.jpg

LM Start	0.00	Rating **	A	Issue No.	13 (cont)
LM End	0.00	Issue Type +	Ma	Location *	WS
Category	Structures & Concrete Lined Channels			GPS Latitude/Longitude	
				Start	End
Item	Electric Gate Operators			37.201538 °	37.201538 °
				-120.694813 °	-120.694813 °
DWR ID	DWR_NA0010_44_t_2012_13				
Action/Comments					
Inspector Comments: Electrical gates appear to be in proper working condition.

Looking south at typical view of electric gate operators on downstream side of structure.

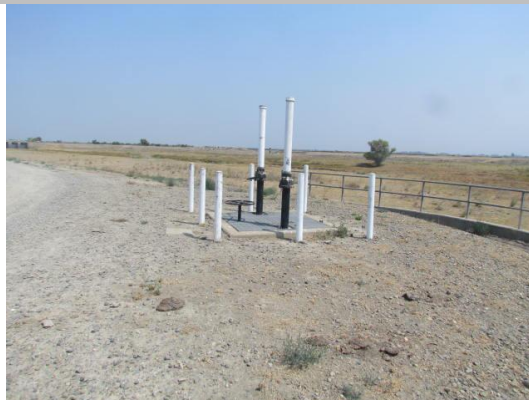
Photo 2 of 3 : ST_2014_NA0010_44_14_20140812_00016.jpg

LM Start	0.00	Rating **	M	Issue No.	14
LM End	0.00	Issue Type +	Ma	Location *	WS
Category	Structures & Concrete Lined Channels			GPS Latitude/Longitude	
				Start	End
Item	Manual Gate Operators			37.201538 °	37.201538 °
				-120.694813 °	-120.694813 °
DWR ID	DWR_NA0010_44_t_2013_14				
Action/Comments					
Inspector Comments: Manual gate stem bent.

Looking north at manual gate operator on downstream side of structure.

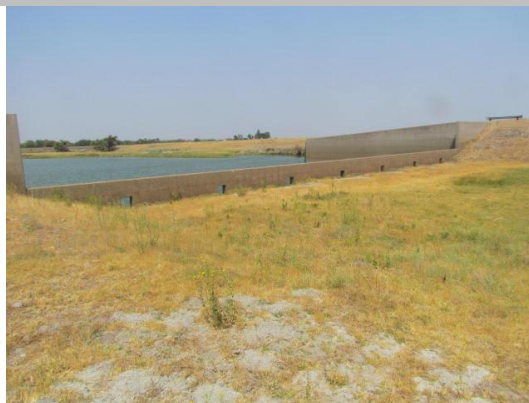
Photo 1 of 4 : ST_2014_NA0010_31_1_20140812_00008.jpg

Looking east at overview of structure.

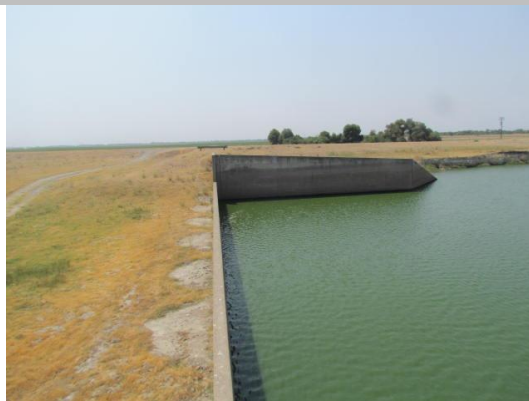
Photo 2 of 4 : ST_2014_NA0010_31_1_20140812_00009.jpg

Looking south at left wing wall.

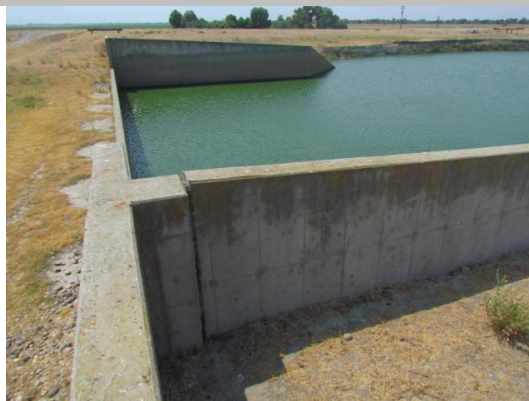
Photo 3 of 4 : ST_2014_NA0010_31_1_20140812_00010.jpg

Looking south at overview of structure.

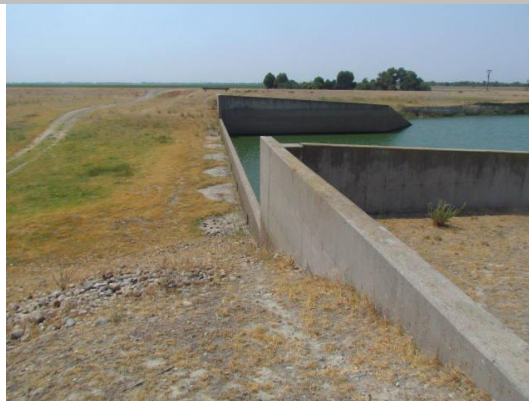
Photo 4 of 4 : ST_2014_NA0010_31_1_20140812_00011.jpg

LM Start	0.00	Rating **	N	Issue No.	1 (cont)	
LM End	0.00	Issue Type +	Ma	Location *		
Category	Structures & Concrete Lined Channels			GPS Latitude/Longitude		
				Start	End	
Item	Photo Documentation			37.201227 °	37.201227 °	
				-120.755223 °	-120.755223 °	
DWR ID	DWR_NA0010_31_t_2012_1					
Action/Comments						
Inspector Comments: Structure appears to be maintained and able to

Looking south at upstream side of structure.

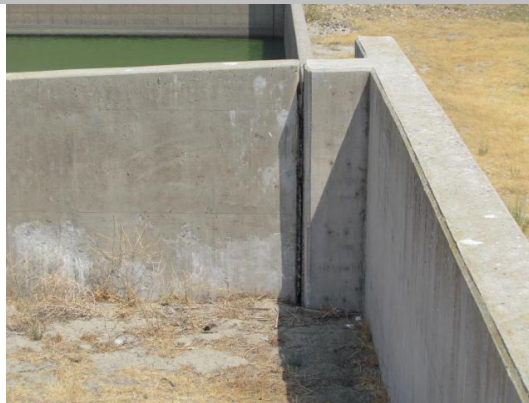
Photo 1 of 3 : ST_2014_NA0010_31_22_20140812_00012.jpg

LM Start	0.00	Rating **	A	Issue No.	22
LM End	0.00	Issue Type +	Ma	Location *	
Category	Structures & Concrete Lined Channels			GPS Latitude/Longitude	
				Start	End
Item	Monolith Joints			37.201227 °	37.201227 °
				-120.755223 °	-120.755223 °
DWR ID	DWR_NA0010_31_t_2012_22				
Action/Comments					
Inspector Comments: Some movement at left wing wall joints.

Looking north at left wing wall.

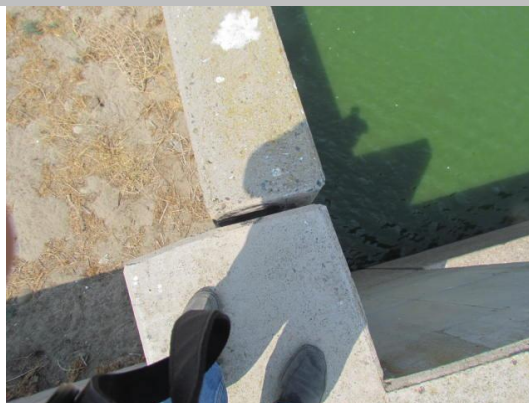
Photo 2 of 3 : ST_2014_NA0010_31_22_20140812_00013.jpg

Looking at top of left wing wall.

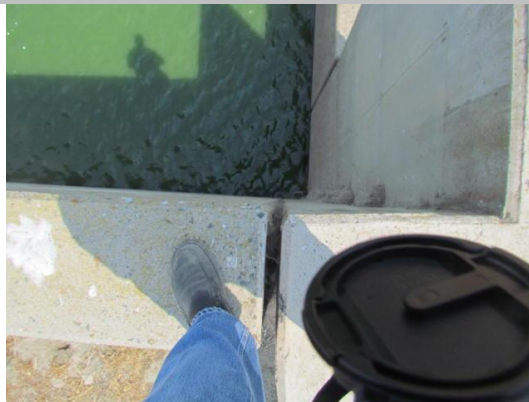
Photo 3 of 3 : ST_2014_NA0010_31_22_20140812_00014.jpg

Looking at top of left wing wall with no rubber gasket in joint.

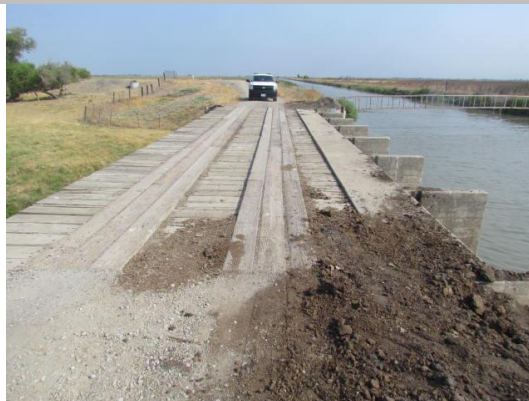
Photo 1 of 4 : ST_2014_NA0010_49_1_20140813_00013.jpg

Looking north at overview of structure.

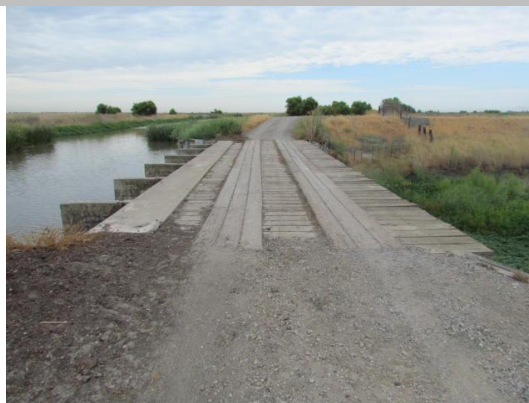
Photo 2 of 4 : ST_2014_NA0010_49_1_20140710_00002.jpg

Looking south at overview of structure.

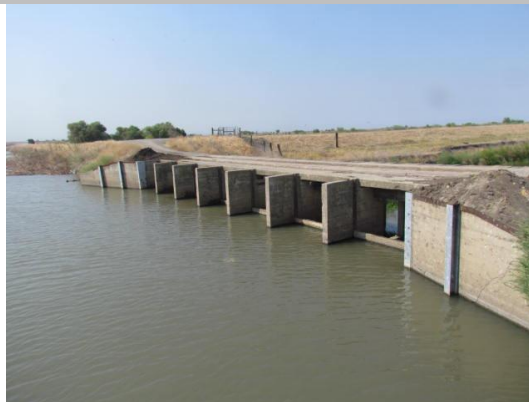
Photo 3 of 4 : ST_2014_NA0010_49_1_20140813_00014.jpg

Looking at upstream side of structure.

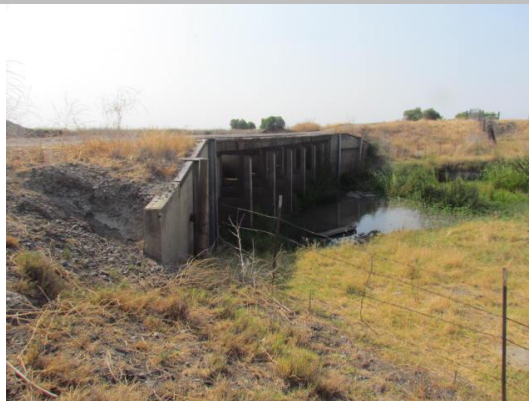
Photo 4 of 4 : ST_2014_NA0010_49_1_20140813_00015.jpg

Looking at downstream side of structure.

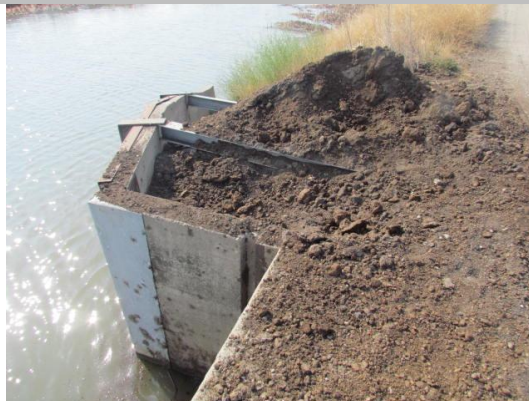
Photo 1 of 2 : ST_2014_NA0010_49_4_20140813_00016.jpg

LM Start	0.00	Rating **	M	Issue No.	4	
LM End	0.00	Issue Type +	Ma	Location *		
Category	Structures & Concrete Lined Channels			GPS Latitude/Longitude		
				Start	End	
Item	Erosion / Bank Caving			37.219788 °	37.219788 °	
				-120.698058 °	-120.698058 °	
DWR ID	DWR_NA0010_49_t_2012_4					
Action/Comments						
Inspector Comments: There is some cracking and animal borrowing occurring on levee embankment on the upstream side near the right wing wall and on the downstream side near the left wing wall. LMA brought in fill material to backfill holes and erosion sites.

Looking at braces on left wing wall 2014

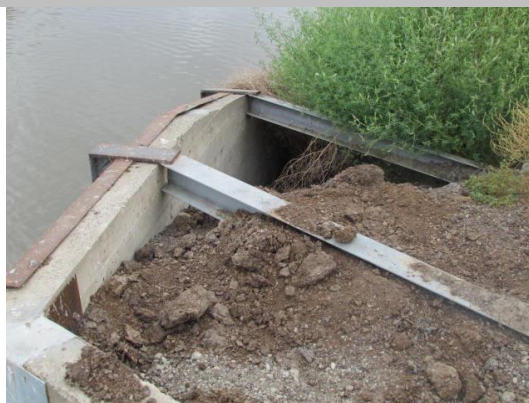
Photo 2 of 2 : ST_2014_NA0010_49_4_20140710_00003.jpg

Looking at new braces on wing wall. 2013

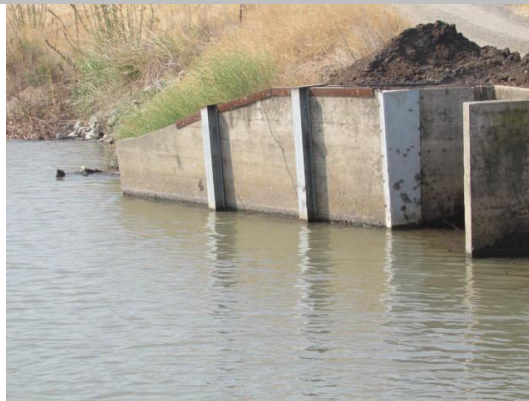
Photo 1 of 7 : ST_2014_NA0010_49_15_20140813_00017.jpg

LM Start	0.00	Rating **	M	Issue No.	15
LM End	0.00	Issue Type +	Ma	Location *	
Category	Structures & Concrete Lined Channels	GPS Latitude/Longitude			
		Start	End		
Item	Concrete Surfaces	37.219788 °	37.219788 °		
		-120.698058 °	-120.698058 °		
DWR ID	DWR_NA0010_49_t_2012_15				
Action/Comments					
Inspector Comments: Small cracking on upstream left and right wing walls. LMA installed metal braces to stabilize the wing walls on the upstream and downstream sides of the structure.

Looking at left wing wall on upstream side of structure 2014

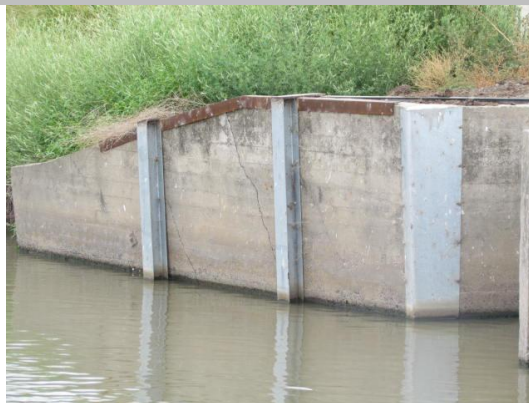
Photo 2 of 7 : ST_2014_NA0010_49_15_20140710_00005.jpg

Looking at left wing wall on upstream side of structure.

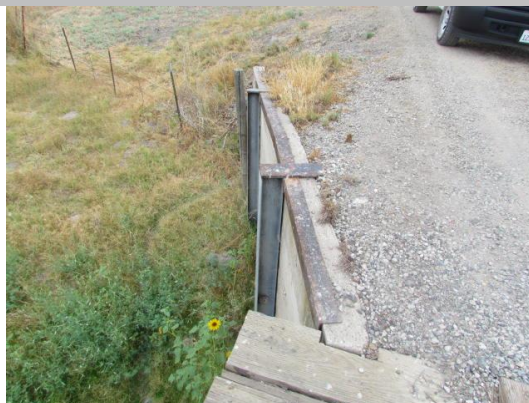
Photo 4 of 7 : ST_2014_NA0010_49_15_20140710_00006.jpg

LM Start	0.00	Rating **	M	Issue No.	15 (cont)	
LM End	0.00	Issue Type +	Ma	Location *		
Category	Structures & Concrete Lined Channels			GPS Latitude/Longitude		
				Start	End	
Item	Concrete Surfaces			37.219788 °	37.219788 °	
				-120.698058 °	-120.698058 °	
DWR ID	DWR_NA0010_49_t_2012_15					
Action/Comments						
Inspector Comments: Small cracking on upstream left and right wing

Looking at right wing wall on upstream side of structure.

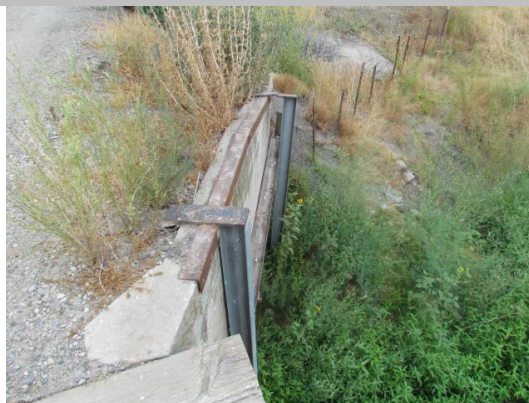
Photo 5 of 7 : ST_2014_NA0010_49_15_20140710_00007.jpg

Looking at left wing wall on downstream side of structure.

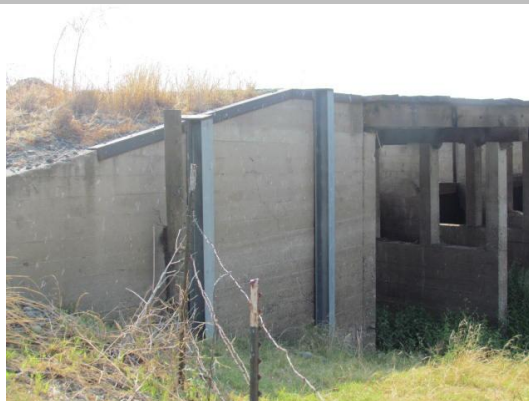
Photo 6 of 7 : ST_2014_NA0010_49_15_20140813_00019.jpg

Looking at right wing wall on downstream side of structure.

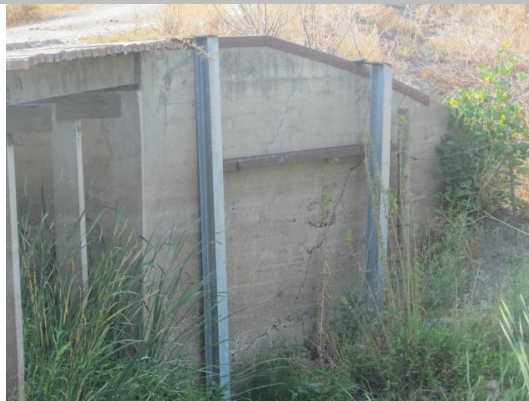
Photo 7 of 7 : ST_2014_NA0010_49_15_20140813_00018.jpg

LM Start	0.00	Rating **	M	Issue No.	15 (cont)	
LM End	0.00	Issue Type +	Ma	Location *		
Category	Structures & Concrete Lined Channels			GPS Latitude/Longitude		
				Start		End
Item	Concrete Surfaces			37.219788 °	37.219788 °	
				-120.698058 °	-120.698058 °	
DWR ID	DWR_NA0010_49_t_2012_15					
Action/Comments						
Inspector Comments: Small cracking on upstream left and right wing

Looking southeast at left wing wall.

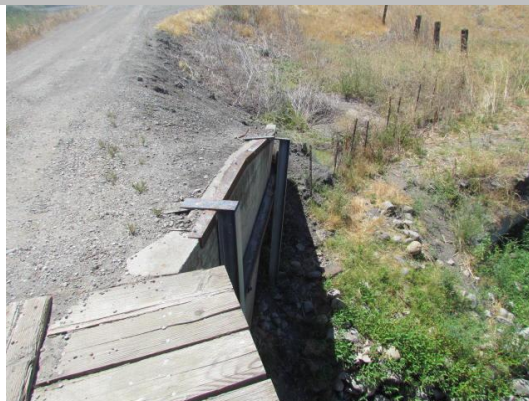
Photo 1 of 2 : ST_2014_NA0010_49_16_20140710_00009.jpg

LM Start	0.00	Rating **	M	Issue No.	16
LM End	0.00	Issue Type +	Ma	Location *	
Category	Structures & Concrete Lined Channels			GPS Latitude/Longitude	
				Start	End
Item	Concrete Tilting / Settlement			37.219788 °	37.219788 °
				-120.698058 °	-120.698058 °
DWR ID	DWR_NA0010_49_t_2012_16				
Action/Comments					
Inspector Comments: Concrete tilting/settlement on upstream and downstream left wing walls has been stabilized by the LMA.

Looking west at brace on right wing wall on downstream side of structure. Summer 2012

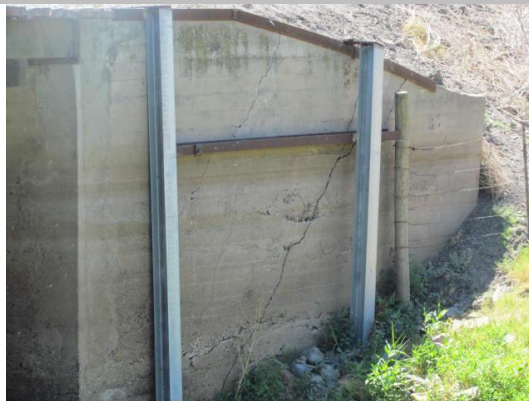
Photo 2 of 2 : ST_2014_NA0010_49_16_20140710_00010.jpg

Looking at repaired right wing wall on downstream side of structure. Summer 2012

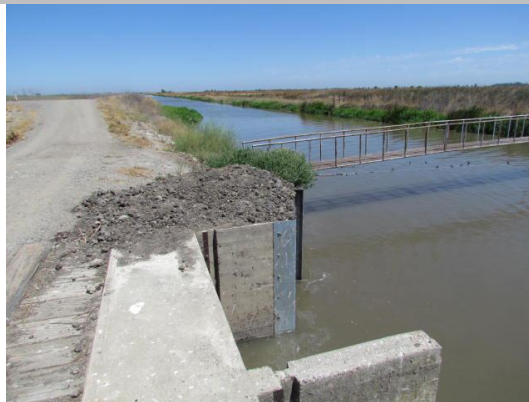
Photo 1 of 2 : ST_2014_NA0010_49_22_20140710_00011.jpg

LM Start	0.00	Rating **	M	Issue No.	22
LM End	0.00	Issue Type +	Ma	Location *	
Category	Structures & Concrete Lined Channels			GPS Latitude/Longitude	
				Start	End
Item	Monolith Joints			37.219788 °	37.219788 °
				-120.698058 °	-120.698058 °
DWR ID	DWR_NA0010_49_t_2012_22				
Action/Comments					
Inspector Comments: Left & right wing walls joints have been repaired, but still unstable.

Looking at repaired right wing wall on upstream side of structure.
